# Manhole Inspection Summary

Manhole # S41E\_\_053MH

Insp Date: **2/24/09 1:19 PM**

**Location** Address: **1263 e fayette av**

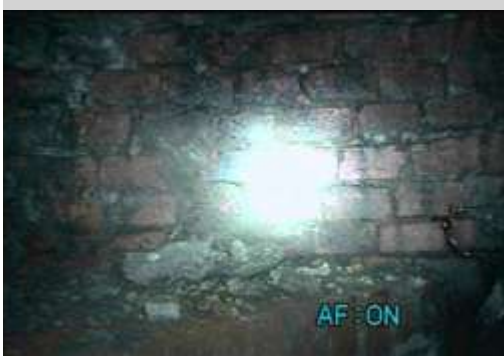
Defect 3

Condition: ☐ Sound ☐ Cracked ☐ Root Intrusion ☐ Deteriorated ☐ Leaks ☒ **Debris**

bench debris

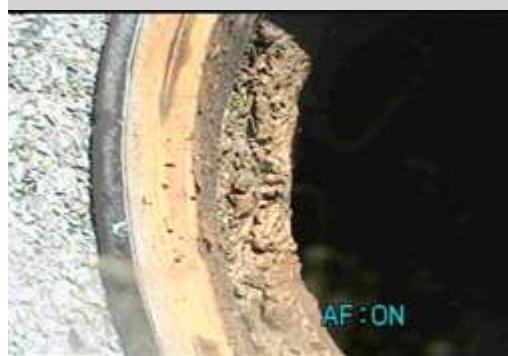
Defect 2

Offset: **3** (in.)

offset

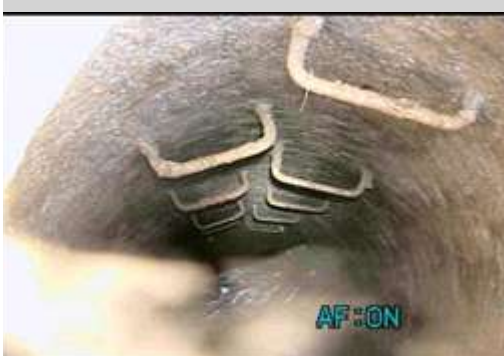
Defect 1

Count: **9** Missing: **0** ☒ **Corroded**

corr steps

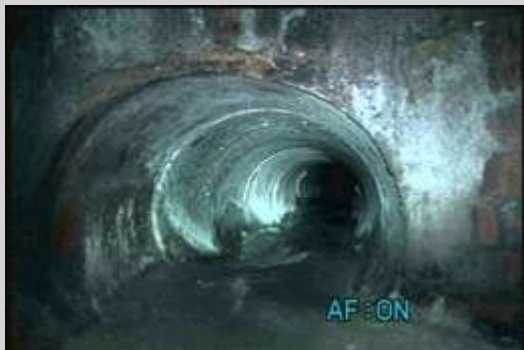
12 O'Clock Outflow

21 in. Circular Gravity Sewer  
Pipe Out @ 12 OClock

Invert Depth: 16.33 (ft.) Flow Characteristics: **Fast**

Infiltration: **None** Pipe Seal Cond: **Unknown**

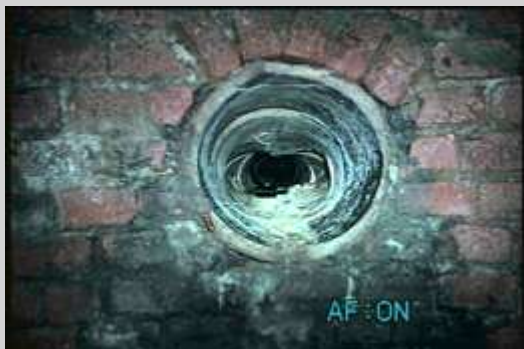
3 O'Clock Inflow

10 in. Circular Gravity Sewer  
Pipe In @ 3 OClock

Invert Depth: 11.38 (ft.) Flow Characteristics: **Slow**

Infiltration: **None** Pipe Seal Cond: **Unknown**

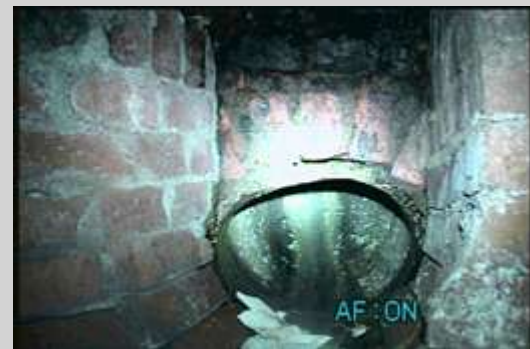
Drop In @ 3 OClock

Drop: **Outside Direct**

Inv Depth: 15.50 (ft.)

Drop Condition: **Open**

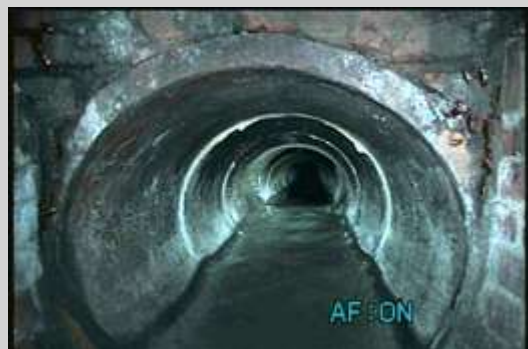
7 O'Clock Inflow

24 in. Circular Gravity Sewer  
Pipe In @ 7 O'Clock

Invert Depth: **16.25** (ft.) Flow Characteristics: **Fast**

Infiltration: **None** Pipe Seal Cond: **Unknown**
